Manhole Inspection Summary

Manhole # S33OO_029MH

Insp Date: **4/24/07 9:53 AM**

Location Address: **2223 HOWARD ST**

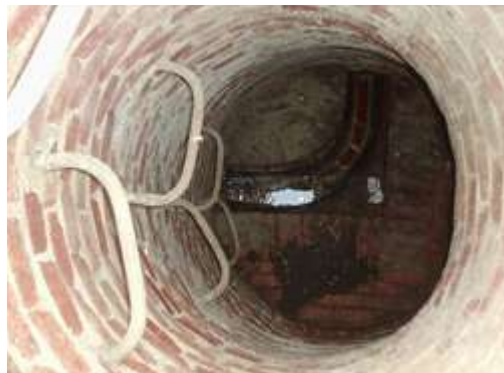
Top View

Barrel infiltration. Evidence of surcharge - Bench debris. Channel debris.

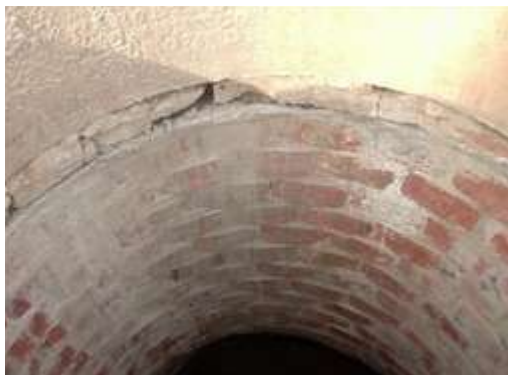
Defect

Frame leaks. Adjustment deterioration and infiltration - other side.

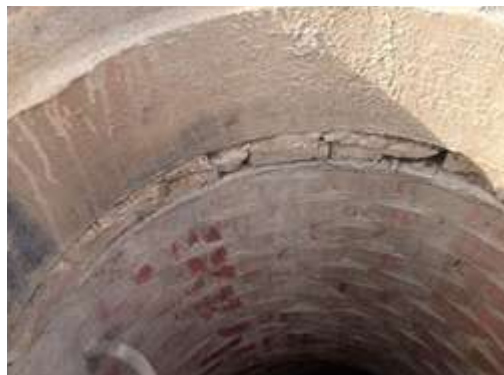
Defect

Frame leaks. Adjustment deterioration and infiltration.

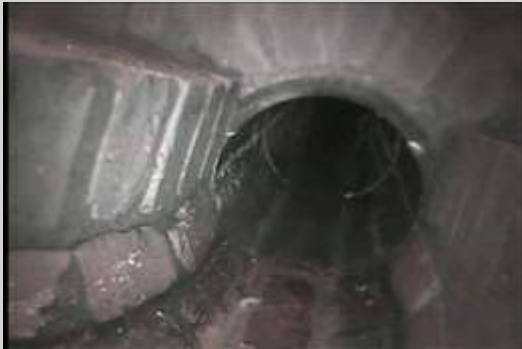
8 in. Circular Gravity Sewer Pipe Out @ 12 O'Clock

Infiltration: **Evidence** Pipe Seal Cond: **Unknown**

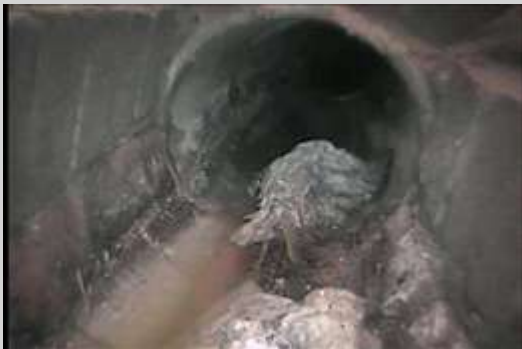
8 in. Circular Gravity Sewer Pipe In @ 9 O'Clock

Deposits: ☐ None ☐ Mud ☐ Sludge ☒ **Debris** ☐ Grease

Silt Depth: **0** (in.) Deposits Extent: **Light**
